24p-0.75⁷ - NRL Memorandum Report 1524

FRACTURE ANALYSIS OF A C-141 LANDING GEAR CYLINDER

C. D. BEACHEM

APRIL 1964

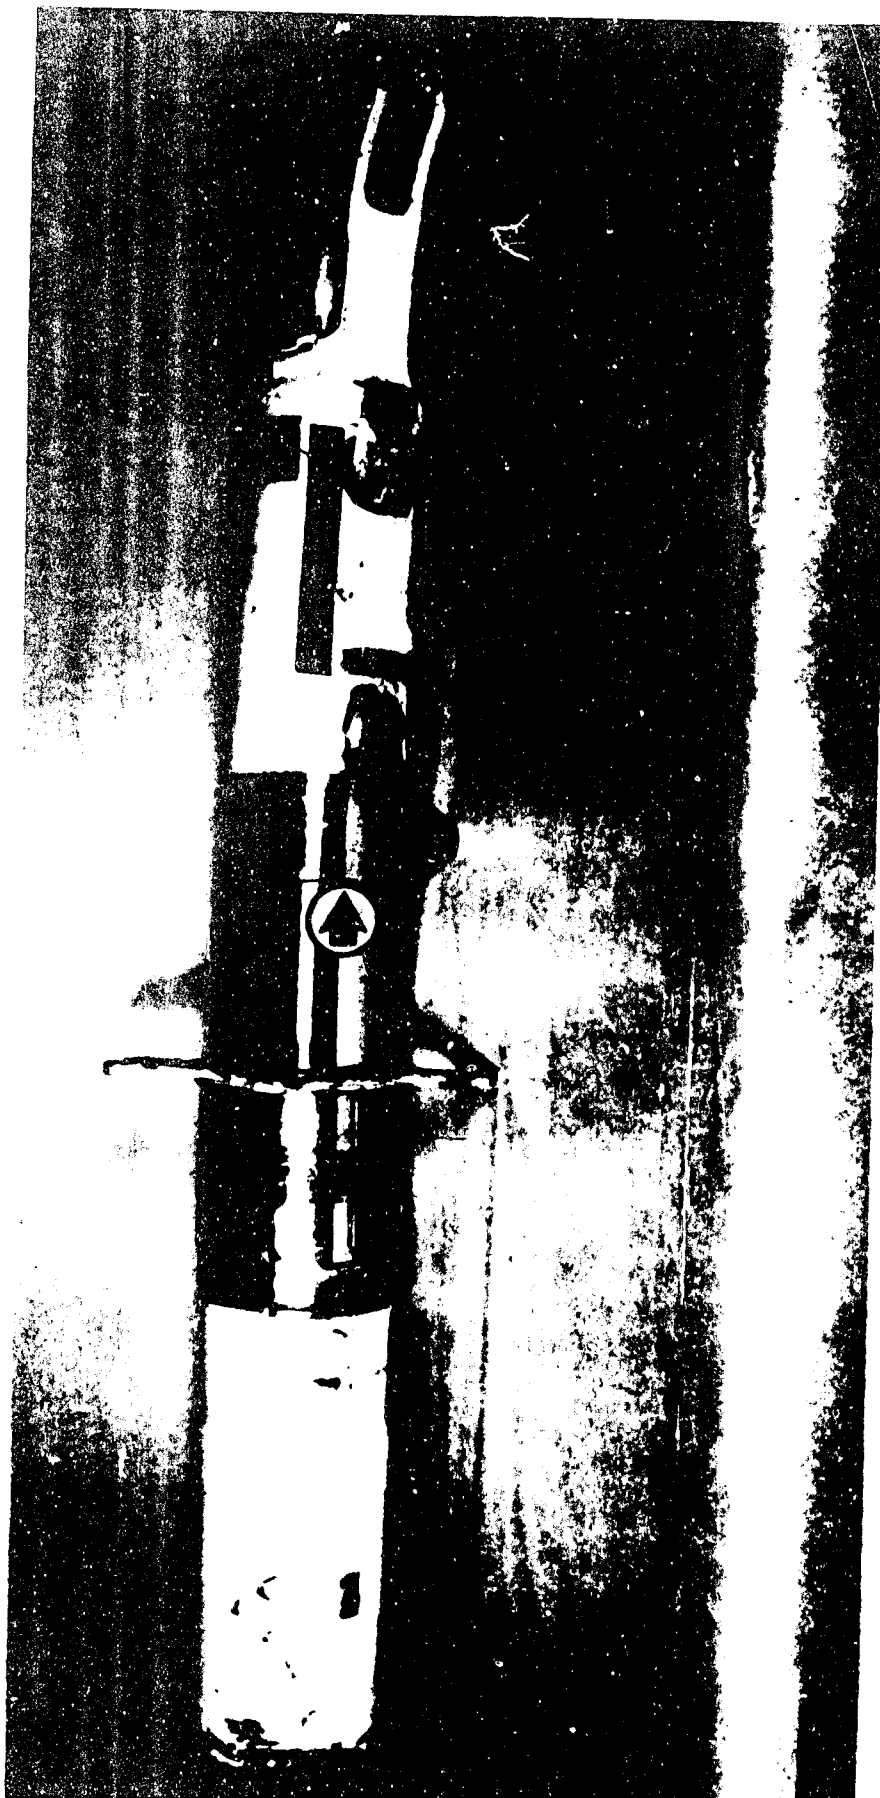
The cylinder is shown in Figs. 1 and 2 with arrows locating the fracture origin (courtesy of Mr. Whiton). The fracture origin is shown at a higher magnification in Fig. 3. A small shallow surface crack which initiated the fracture is shown between the two vertical arrows. Several small flat-topped hills and flat-bottomed holes are indicated by the other arrows. These were found only near the fracture origin.

Fig. 1 - Laboratory tested C-141 nose gear outer cylinder, with arrow showing fracture origin. Photograph courtesy of Lockheed Aircraft Co.

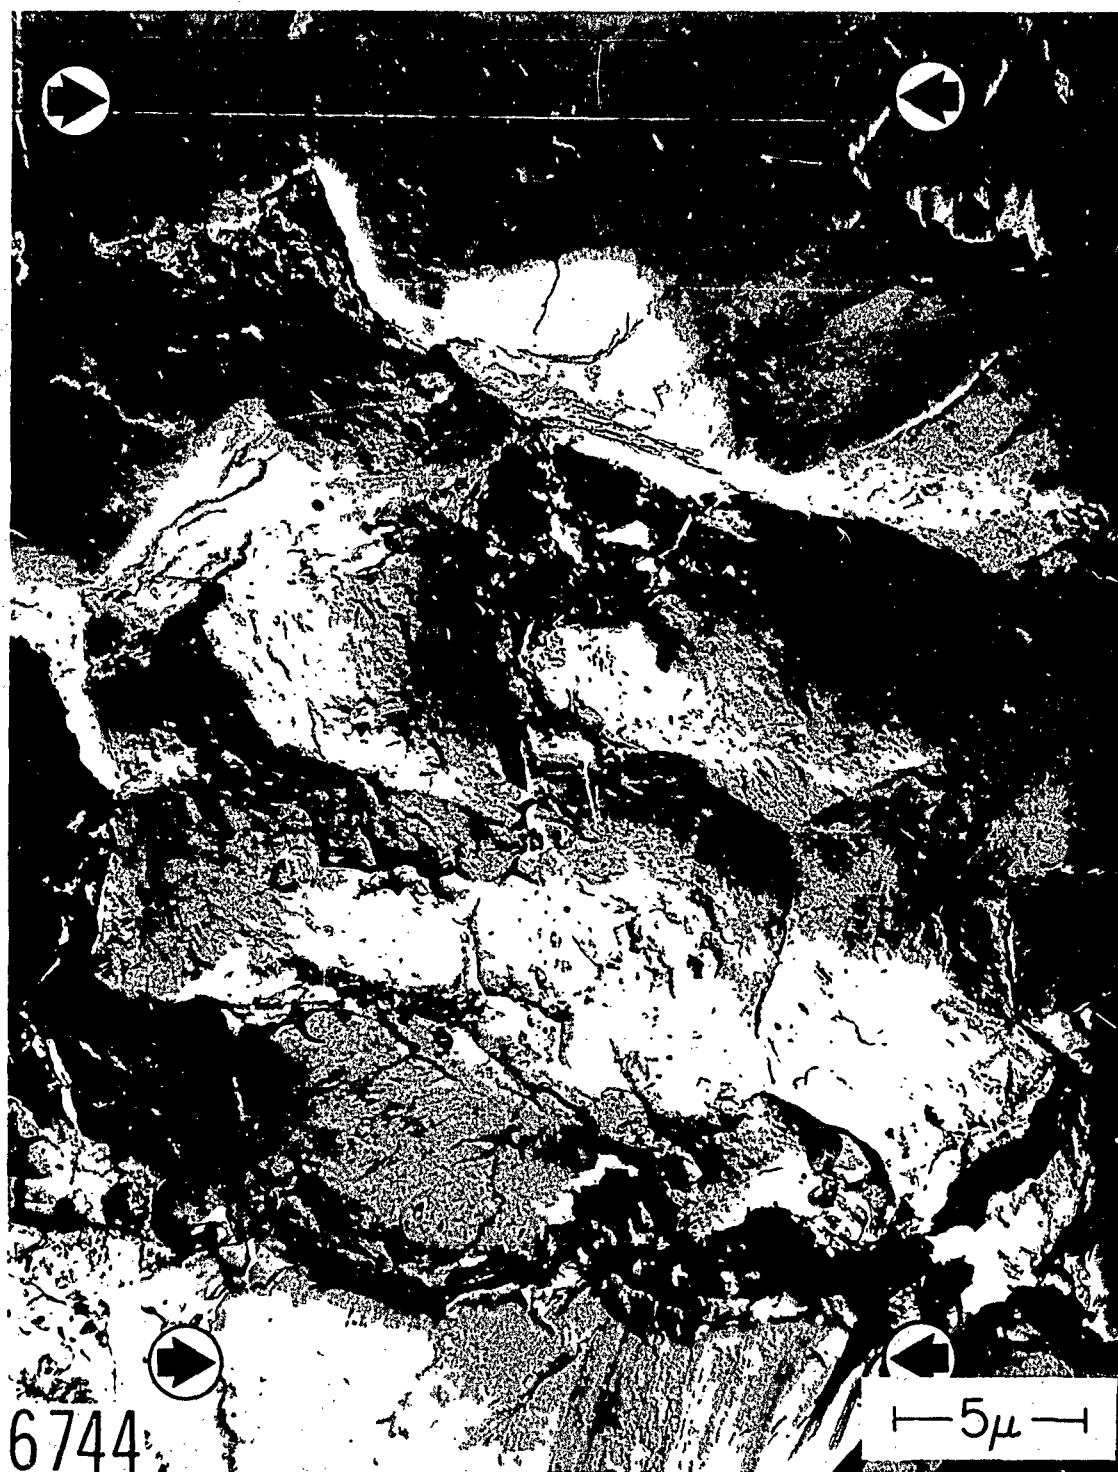
The burnishing markings extended about two or three thousandths of an inch into the specimen. The intergranular region extended in for an additional seven or eight thousandths of an inch. Figs. 6 and 7 show some of these facets. They also show numerous opaque particles and only a few dimples. Fig. 6 shows some of the burnishing markings at the top and bottom (horizontal arrows show examples).

measured by the distance between the shear lips (Fig. 3). The depth was measured by the depth of the initial intergranular region. The opaque particles in Figs. 5 and 6 are similar to those seen previously on surface cracks exposed to heat treatment environment (e.g., during tempering).

Fig. 6 - Burnishing markings (arrows), intergranular facets, and opaque particles on the surface of the surface crack where the fracture initiated. Two-stage palladium-shadowed carbon replica. 6000X.

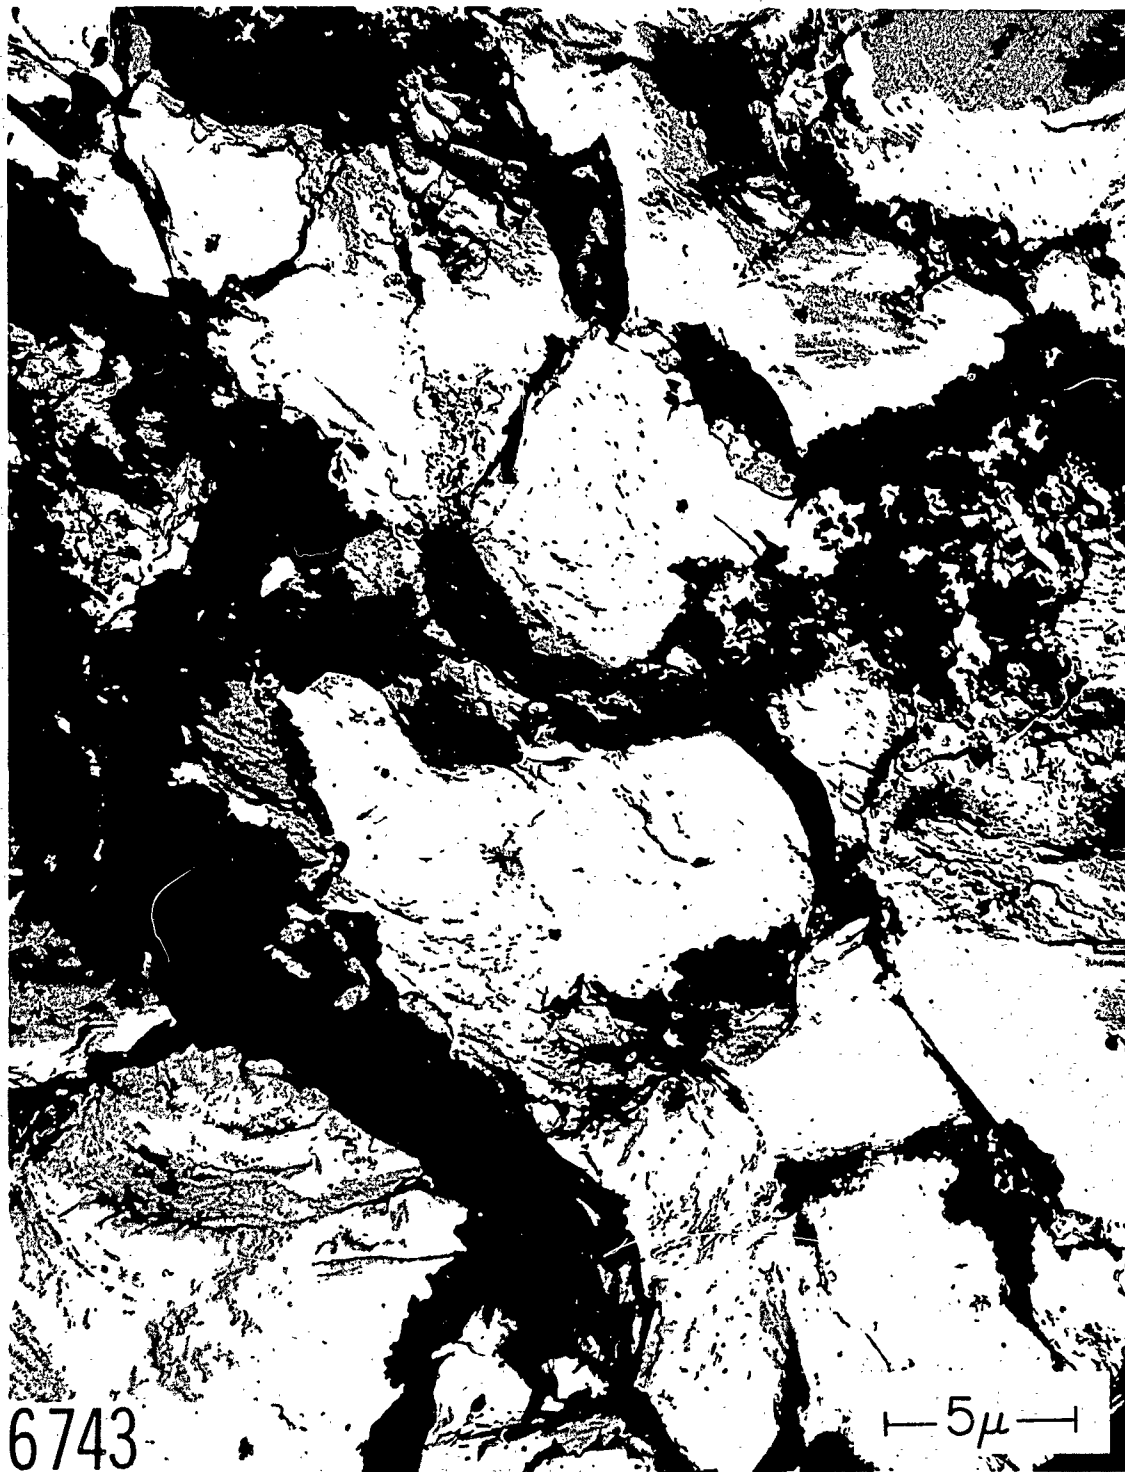
Fig. 7 - Grain facets and opaque particles on surface of shallow surface crack. Two-stage palladium-shadowed carbon replica. 6000X.

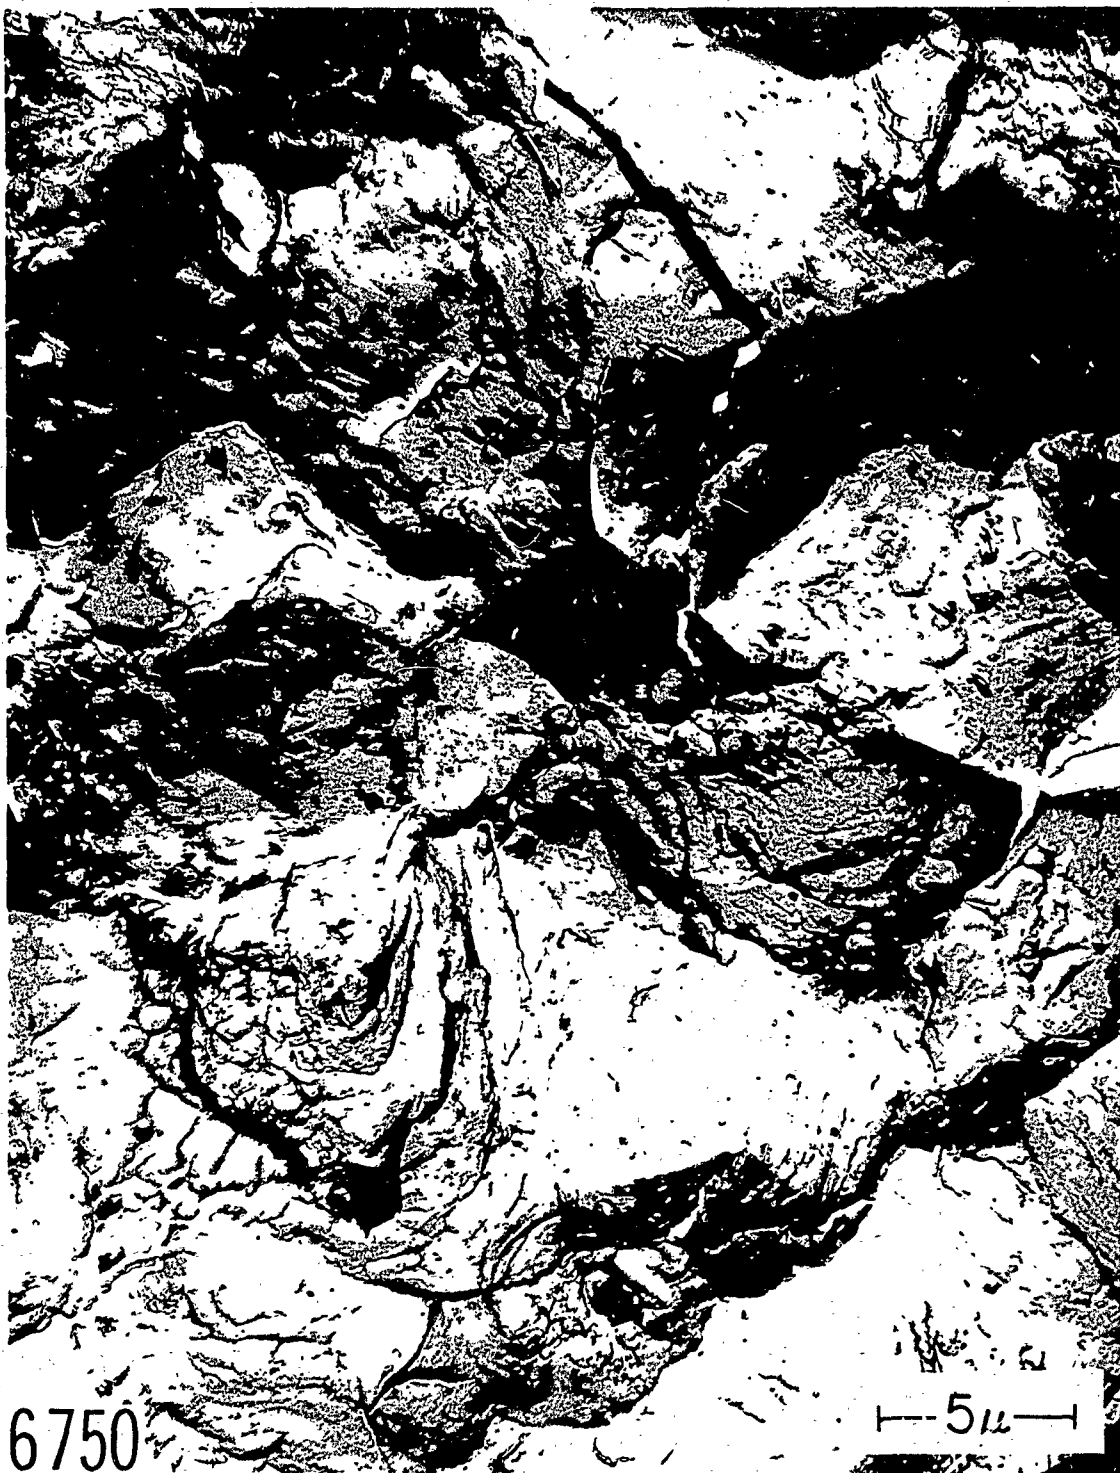
About 10 thousandths of an inch from the outer surface the fracture mode changed from almost totally intergranular to mixed intergranular and dimples as shown in Figs. 8-10. The remainder of the fracture surface was a mixture of intergranular fracture and dimples, such as those shown,

Fig. 8 - Mixed intergranular fracture and dimples typical of some plane-strain fracture surfaces in 4340 steel. View of fracture surface beneath the surface flaw. Other typical regions are shown in Figs. 8 and 9. Two-stage palladium-shadowed carbon replica. 6000X.

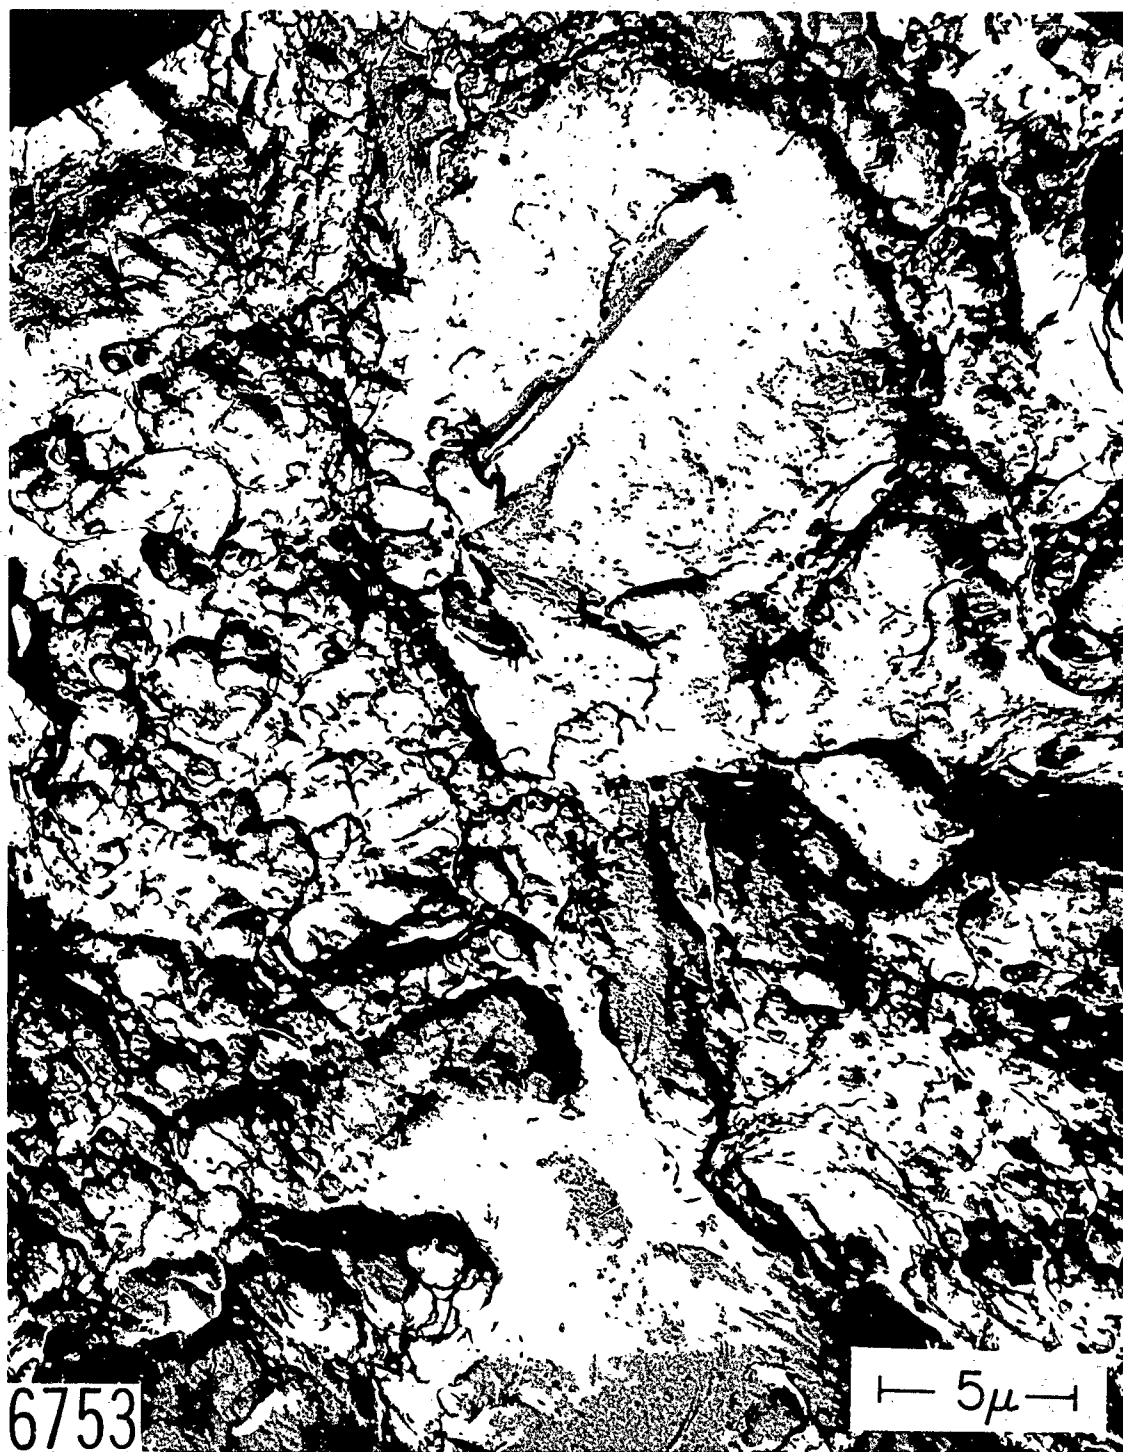
Fig. 10 - Another region below the surface crack which exhibits a different arrangement of mixed intergranular fracture and dimpling. Two-stage palladium-shadowed carbon replica. 6000X.

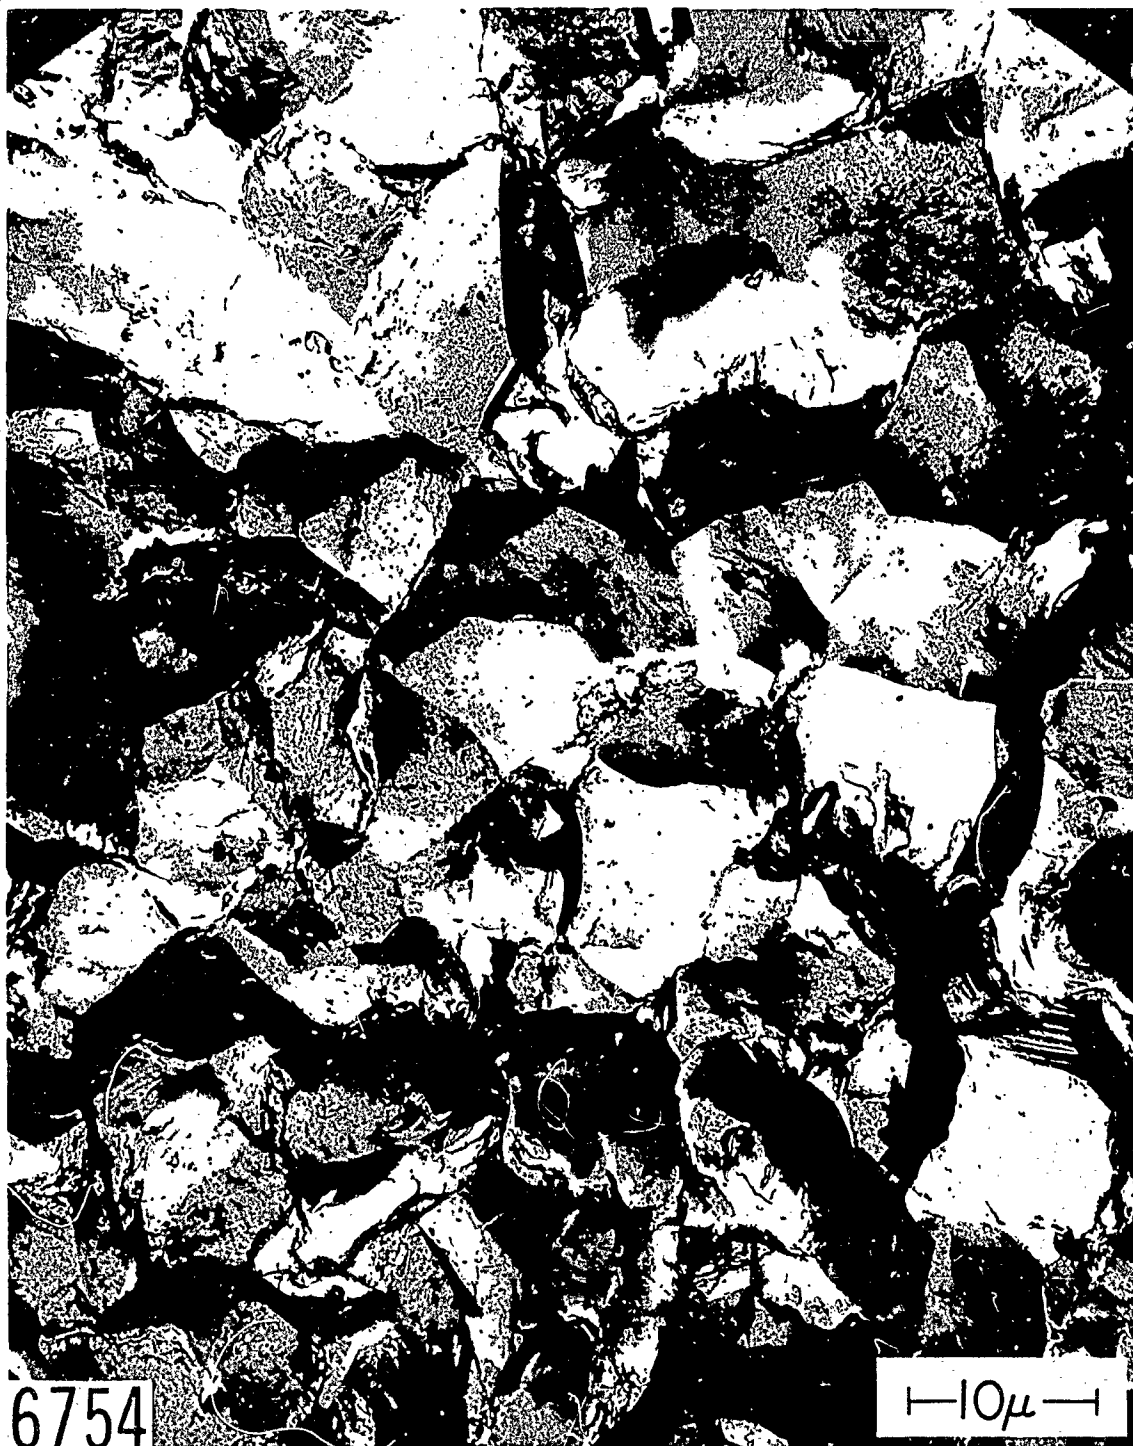
except for the small isolated patches of completely intergranular fracture in the macroscopically flat bottoms of holes and tops of "mesas" shown at low magnification in Fig. 3 and at high magnification in Fig. 11. Fig. 12 is a low magnification electron fractograph showing the collapsed sides of a "mesa". (Large elevation changes in replicas like these collapse due to the surface tension of the acetone when the replicas are placed onto grids and removed from the acetone.)

Fig. 11 - Completely intergranular fracture typical of the surfaces at the bottoms of holes and tops of hills located immediately below the surface crack. Two-stage palladium-shadowed replica. Approximately 3000X.

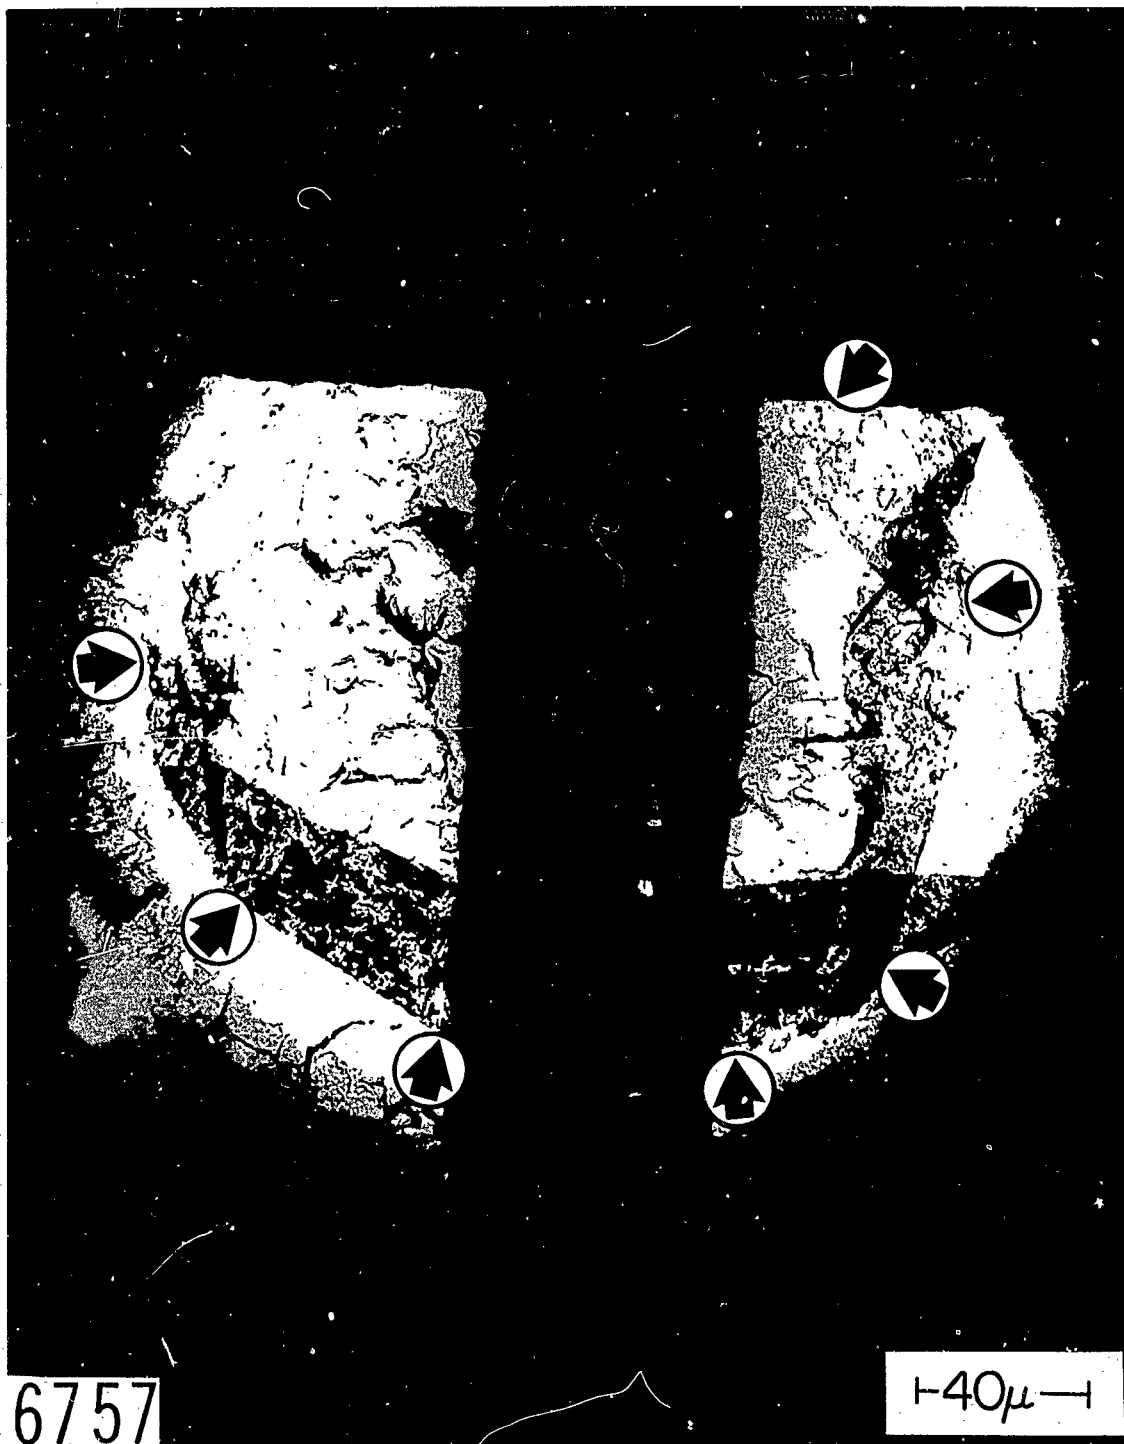
Fig. 12 - Collapsed replica (arrows) showing large and sudden elevation change between the plane of the major fracture and one of the truncated hills or one of the flat-bottomed holes. Two-stage carbon replica. 630 X.
